THE ROCKET-TRIGGERED LIGHTNING INVESTIGATION  
1981 PROGRESS REPORT

Charles W. Schubert, Jr., Major, USAF  
Richard D. Richmond  
Flight Vehicle Protection Branch  
Vehicle Equipment Division

May 1983

Final Report for Period October 1980 through September 1981

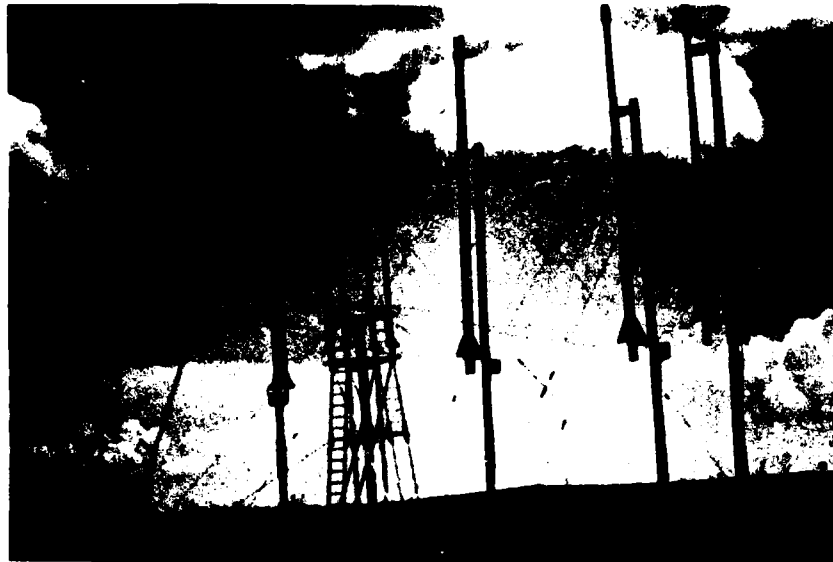
Figure 6. Ground-Based Rocket Launchers

rod served as a corona point to direct lightning current from the wire bottle across an open air gap to the LSO. Six additional wire-and-rocket units were emplaced on the ground at the base of the Strike Scaffold. The aim of these units was to direct lightning strikes adjacent to, but not necessarily onto, the LSO. Figure 6 shows three of the ground-based rocket launchers and corresponding wire bottles. A fourth rocket system, leftmost in the Figure 6 photograph, was used to transmit electrostatic data, and was not part of the wire-and-rocket triggering system. Four additional triggering units were placed on a metal platform (TIPSY) several tens of meters to the east of the Lightning Strike Scaffold. The TIPSY platform, visible in the background in Figure 6, is shown more clearly in Figure 7. The TIPSY wire-and-rocket units were used for French experiments in which a portion of the triggering wire was replaced by a non-conductive line.

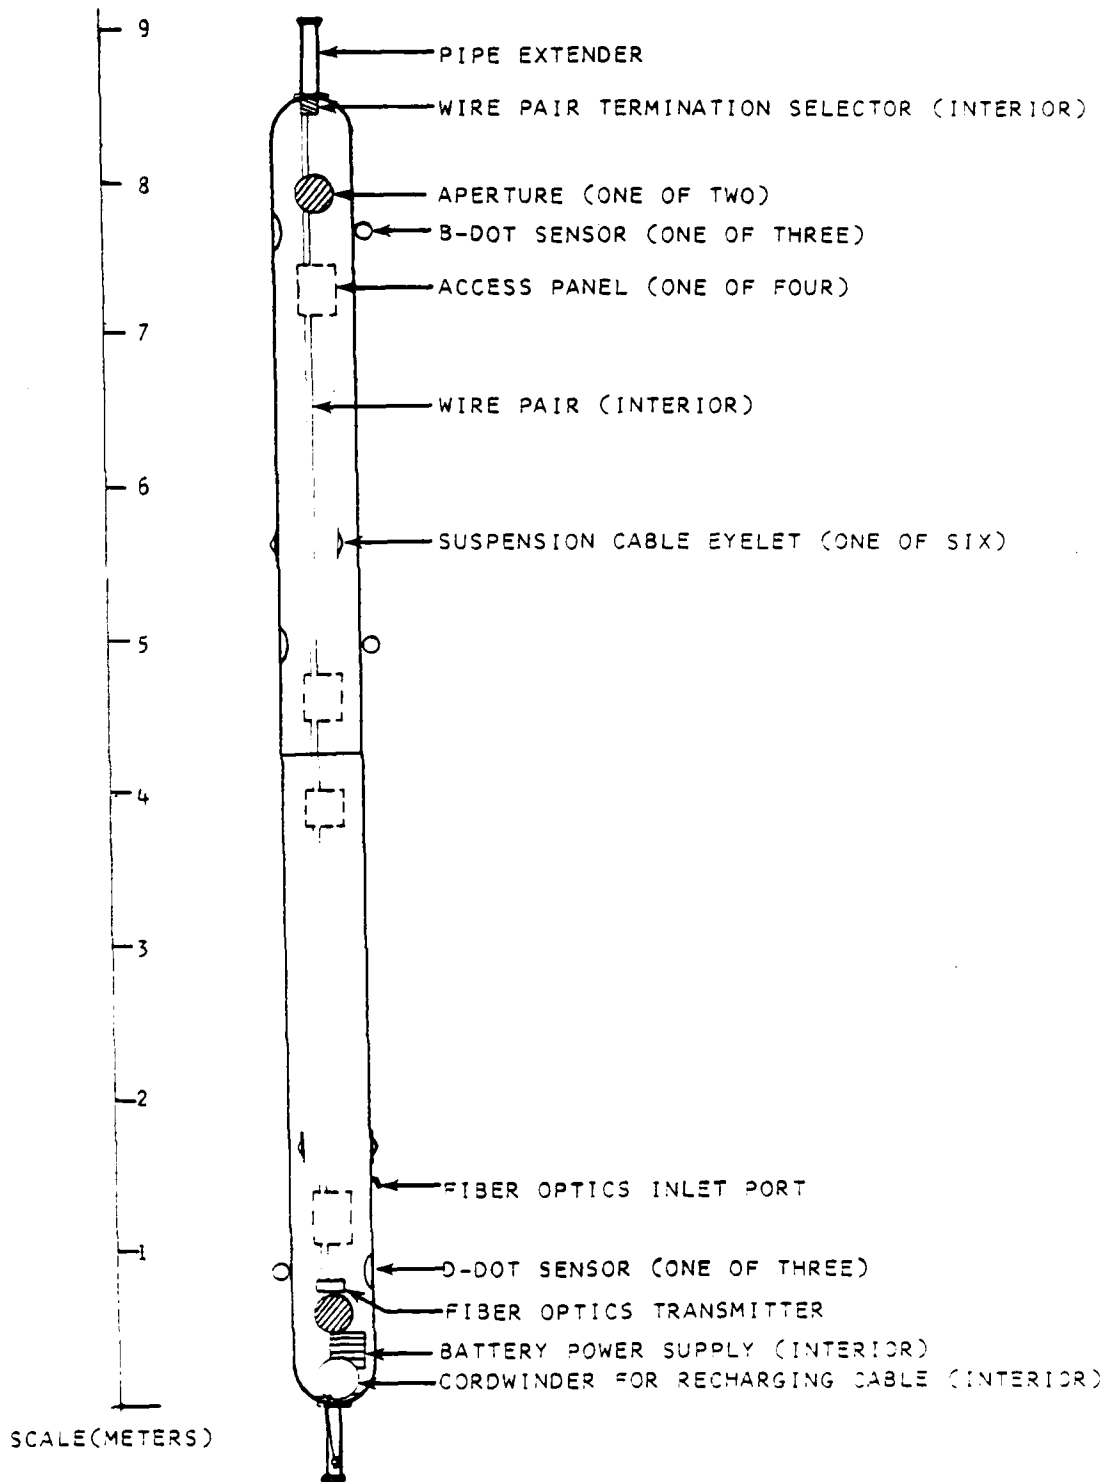
Figure 8. Lightning Strike Object Descriptive Illustration

The LSO sensors were chosen to enable a full characterization of lightning-generated fields and currents at the surface of the LSO. The magnetic field sensors and electric field sensors are designed to respond to the derivative of the fields, and are thus referred to as B-dot and E-dot sensors, respectively. The current transformer outpost is

proportional to the current amplitude on the LSO surface and the slot antenna output is proportional to the current derivative. The wire pair provides data on induced currents within the LSO, which are proportional to the derivative of the external fields. Following is a discussion of each of the sensor types.

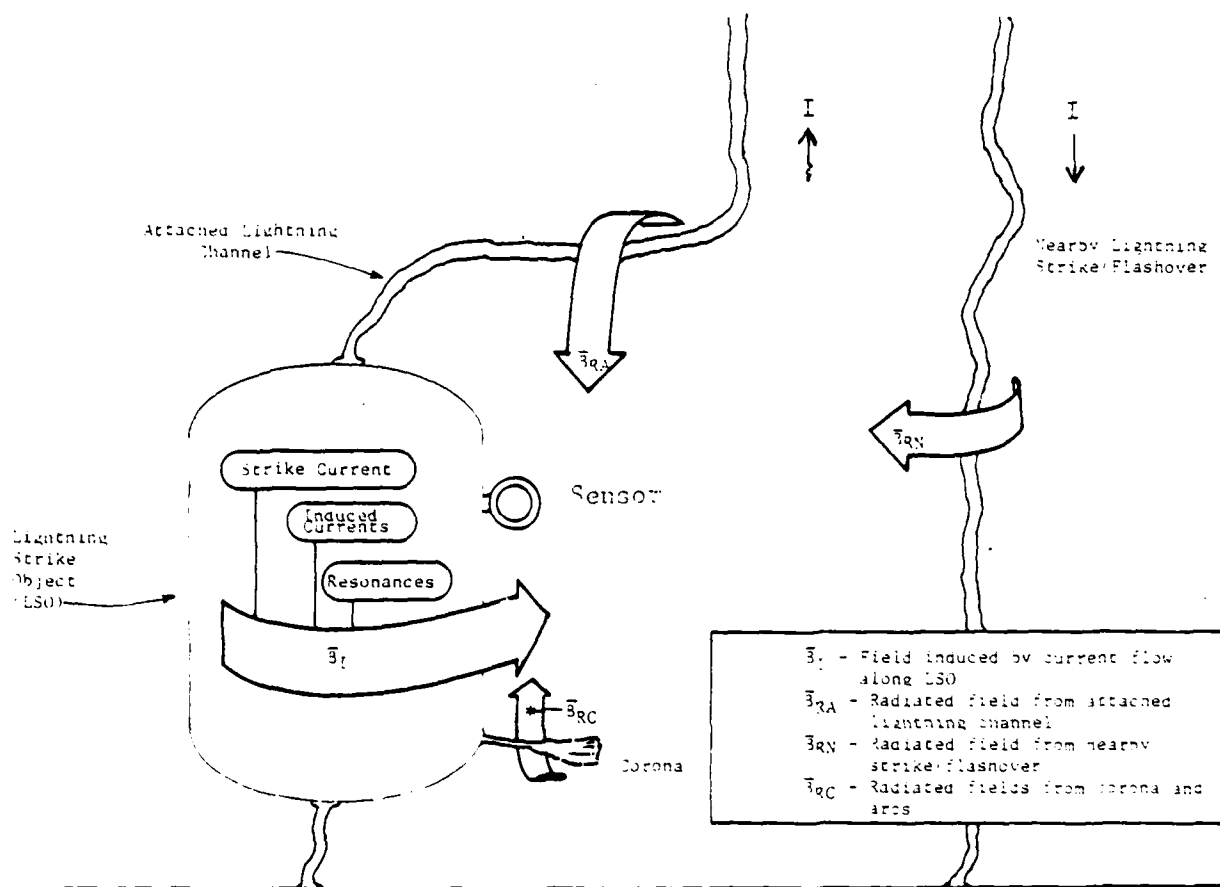
Figure 9. Fields Detected by B-Dot Sensor

strike current will be modified by LSO surface induced currents and by resonances, as indicated in Figure 9. Surface induced currents are produced as a result of LSO immersion in exterior electromagnetic fields, including the  $\bar{B}_{RA}$ ,  $\bar{B}_{RN}$ , and  $\bar{B}_{RC}$  fields considered earlier. Resonances occur because of the impedance mismatch between the LSO surface and the surrounding environment.

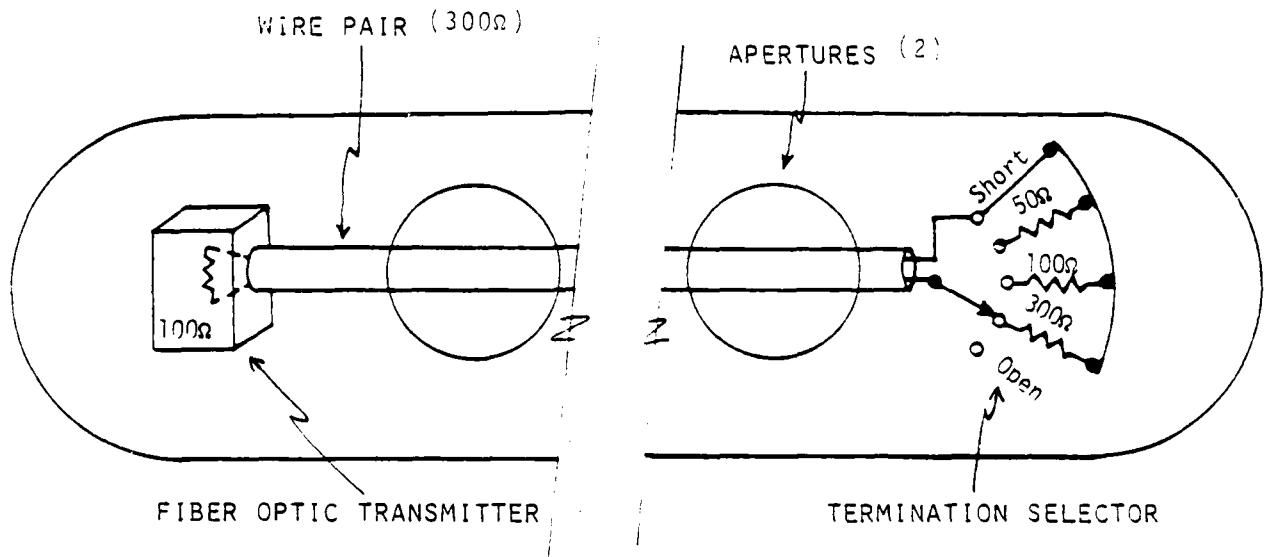
Figure 12. Wire Pair System

To provide information on induced currents, a wire pair is installed along the full length of the LSO interior positioned along the longitudinal center axis. The wire pair system consists of a standard 300 ohm parallel wire television antenna twinlead and a variable termination selector. The selector, mounted on the upper end of the LSO interior, enables termination options of open circuit, short circuit, 50 ohms, 100 ohms, or 300 ohms. A drawing of the wire pair system showing the major components is presented in Figure 12.

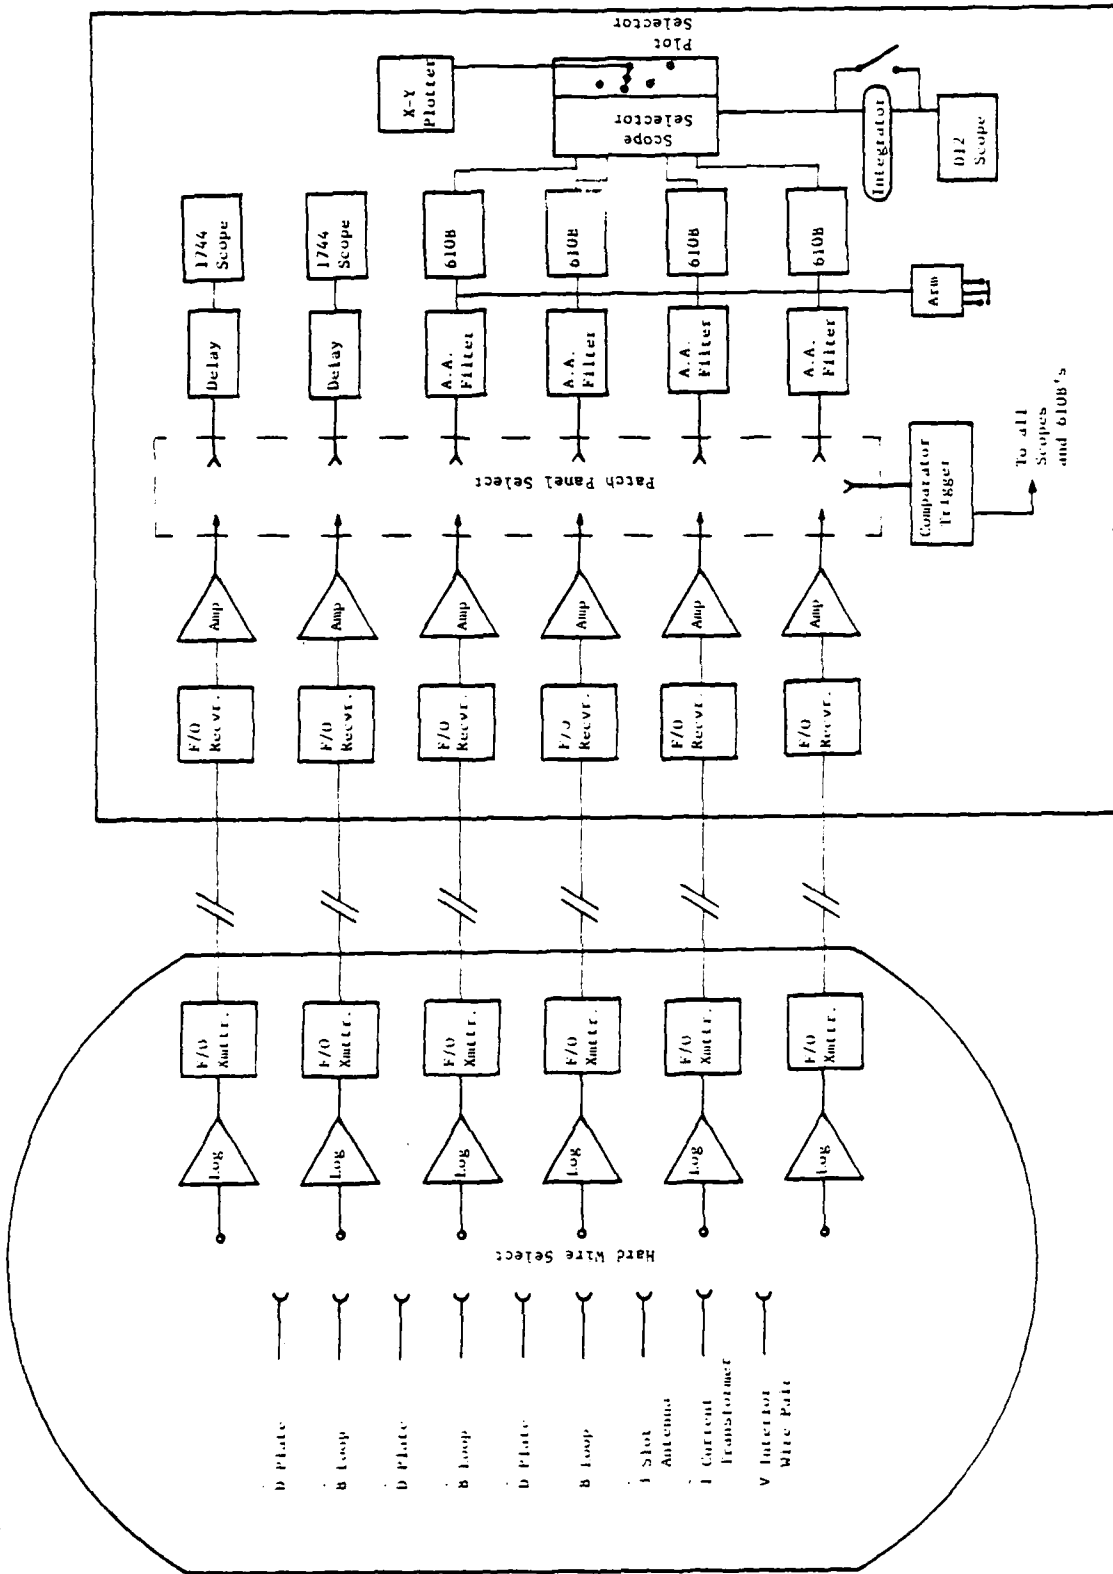
The data transmitting and recording system employed during the 1981 tests is shown schematically in Figure 13. As can be seen from the schematic, any six of the available nine sensors could be chosen for data transmission during a given triggering event. Data from the selected sensors was transmitted from the LSO to the instrumentation van over a fiber optic system consisting of six Meret MDL27802 transmitter/receiver pairs and a bundle of six Meret SDM fiber optic cables. Logarithmic amplifier circuits were used to compress the LSO sensor output signals, expected to reach over 1000 volts during a full strike, to the  $\pm 1$  volt operating range of the fiber optic transmitters. Logarithmic amplifiers, rather than resistive dividers, were used for the attenuation to enable data acquisition over a wide range of voltage levels and to insure system protection in the event of an unexpectedly high voltage surge. Compensation for signal loss resulting from transmittal over the fiber optic cables was accomplished with follow-on amplifiers in the instrumentation van.

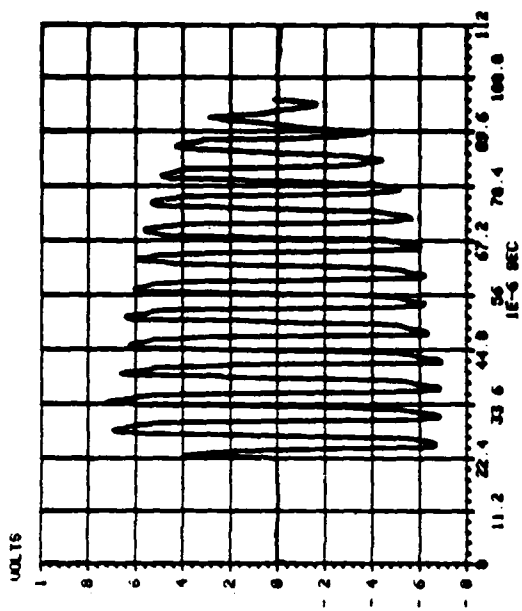
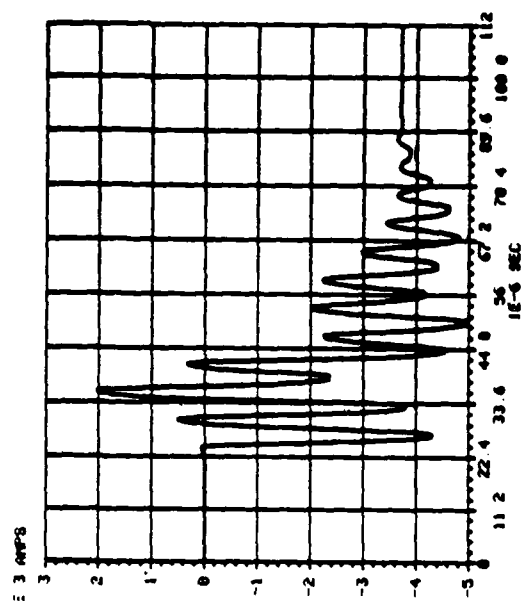
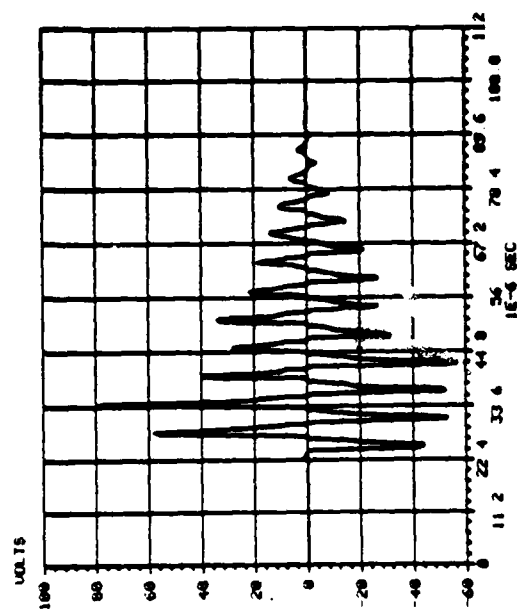
Figure 14. Waveform Processing Example

Figure 14, which shows a waveform at various stages of processing, illustrates the processing sequence and the resultant data degradation for a typical waveform. The damped oscillating waveform of a current pulse injected into one end of the LSO during laboratory testing is shown in Figure 14a. This waveform is the output of a current transformer placed at the injection point, and, except for a scaling factor, represents the actual current along the LSO. The oscillation frequency is that of the combined LSO-pulse generator system. Figure 14b illustrates the corresponding waveform from an LSO B-dot sensor after transmittal to the recording system. Recovery of the true B-dot sensor output requires that the antilog of Figure 14b be taken, using the logarithmic calibration curve for the data channel over which the transmission occurred. Computer application of this antilog process results in the waveform shown in Figure 14c. Use of Equation 5 from Section 5a of this report on Figure 14c produces the waveform shown in Figure 14d. The Figure 14d waveform is the predicted current along the LSO based upon the output of the B-dot sensor. Thus the waveforms in Figures 14a and 14d should be identical. The obvious differences between the two illustrates the degree to which the data could be degraded as a result of processing. Since input functions are known in laboratory testing, obvious processing errors in laboratory waveforms can be deleted and the

degradation minimized. Equivalent errors emerging in the processing of triggered lightning data are much more difficult to identify. Consequently, any interpretation of the 1981 Mt Baldy data set must be made with extreme caution.

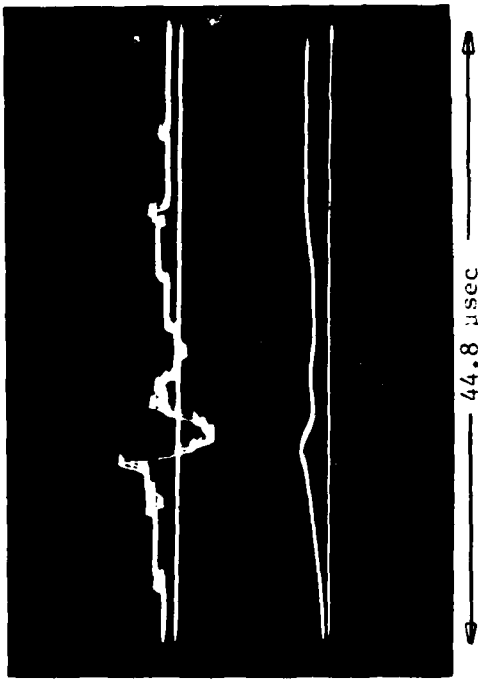
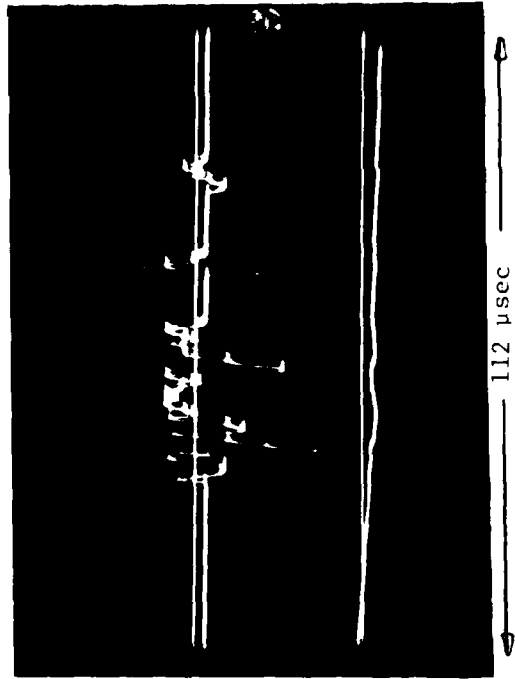
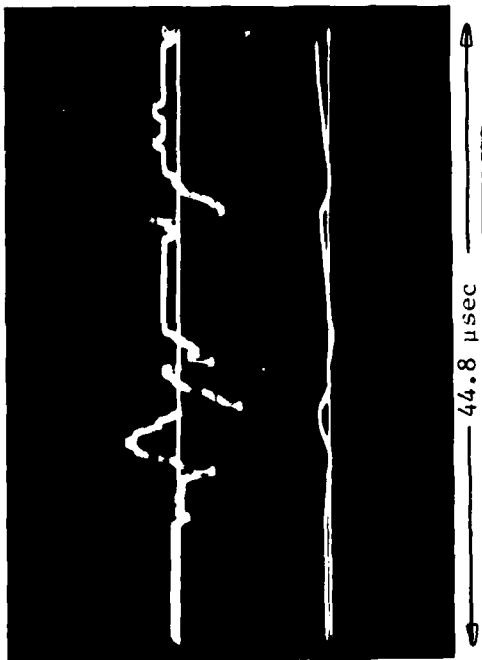
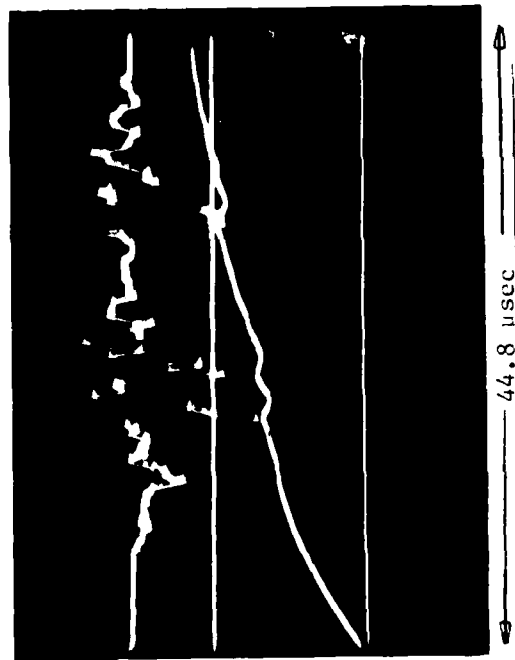
Figure 21. Unprocessed LS0 Data from Lightning Strike of  
14 August 1981, 13:47:52 MST

A similar series of waveforms produced by a TIPSy rocket triggering at 13:47:52 on the same date is presented in Figures 21 and 22.

inversion occurs. This is in contrast with the triggerings of 13:43:13 (Figure 19) and 13:47:52 (Figure 21), in which the waveform from the upper B-dot sensor is an inversion of the waveform from the lower B-dot sensor. A possible physical explanation of the difference is that the waveforms from the 13:37:20 triggering could be due to current flow along the LSO, and the waveforms from the 13:43:13 and 13:47:52 triggerings due to radiated fields from nearby lightning channels. As can be seen in Figure 24, the two situations can produce sensor polarity differences if the B-dot sensors are on opposite sides of the LSO circumference (as is the case for the upper and lower B-dot sensors) and if the two sensors and the lightning channel are in a common plane. Having made this explanation, however, it must be pointed out that in the full 1981 Mt Baldy data set, no clear correspondence between B-dot waveform inversion and lightning channel location can be identified. Difficulties in establishing such lightning/waveform interrelationships prevail throughout the 1981 data, and can be for the most part attributed to the recording system limitations discussed in Section II of this report. Because of these limitations, data reduction and analysis was largely restricted to that necessary to identify needed system improvements.

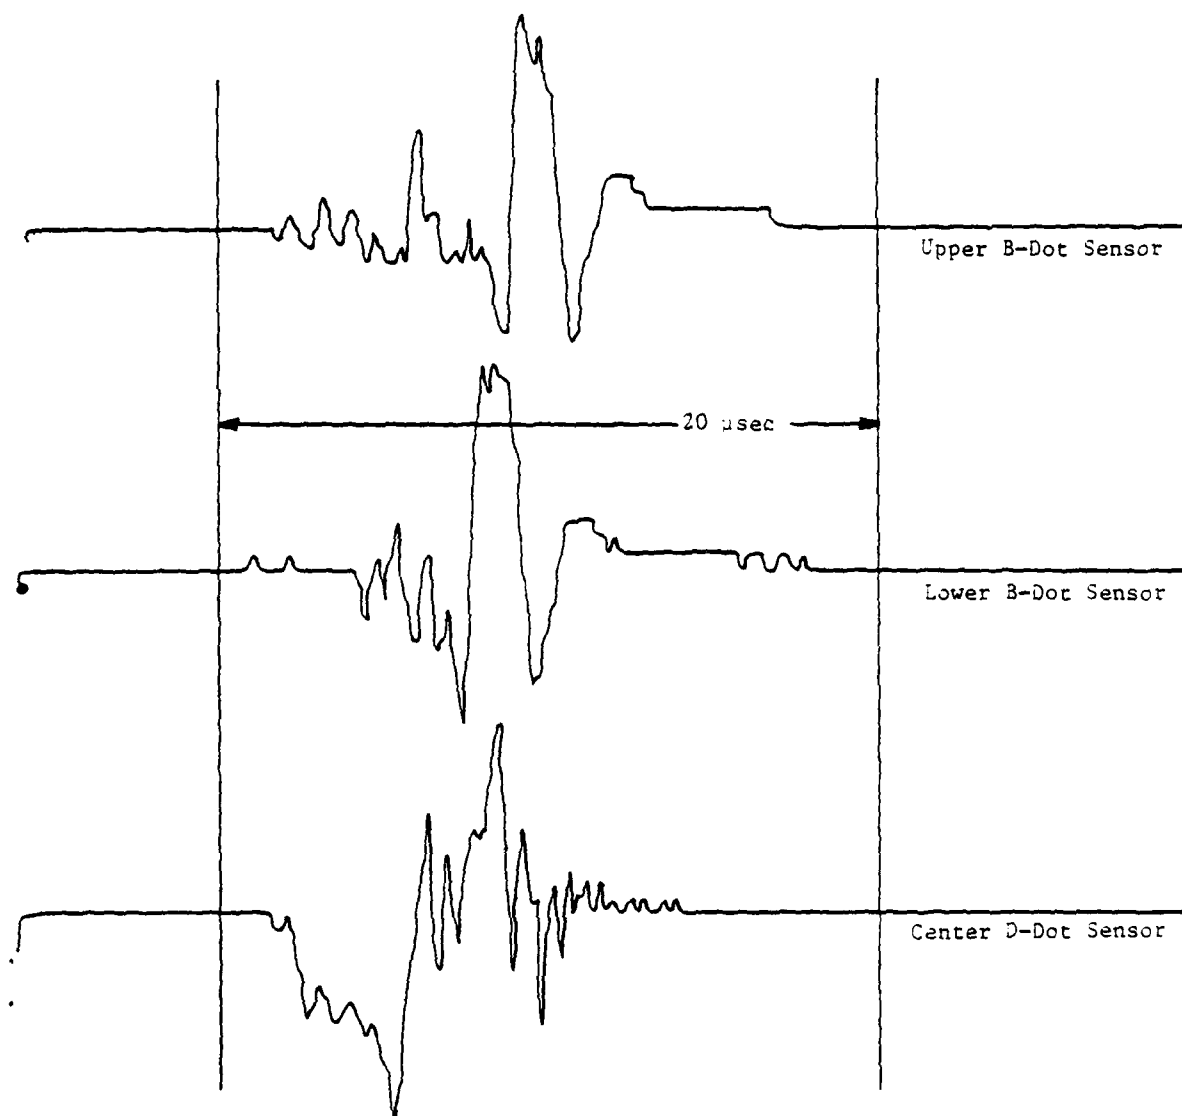
Figure 23. Unprocessed Waveform from Lightning Strike of  
14 August 1981, 13:37:20 MST

Figure 23 shows waveforms resulting from a lightning flash triggered at 13:37:20 by a rocket launched from the top of the Scaffold, also on 14 August. It is interesting to note that, in this triggering, the waveforms from the upper and lower B-dot sensors are in phase; i.e., no

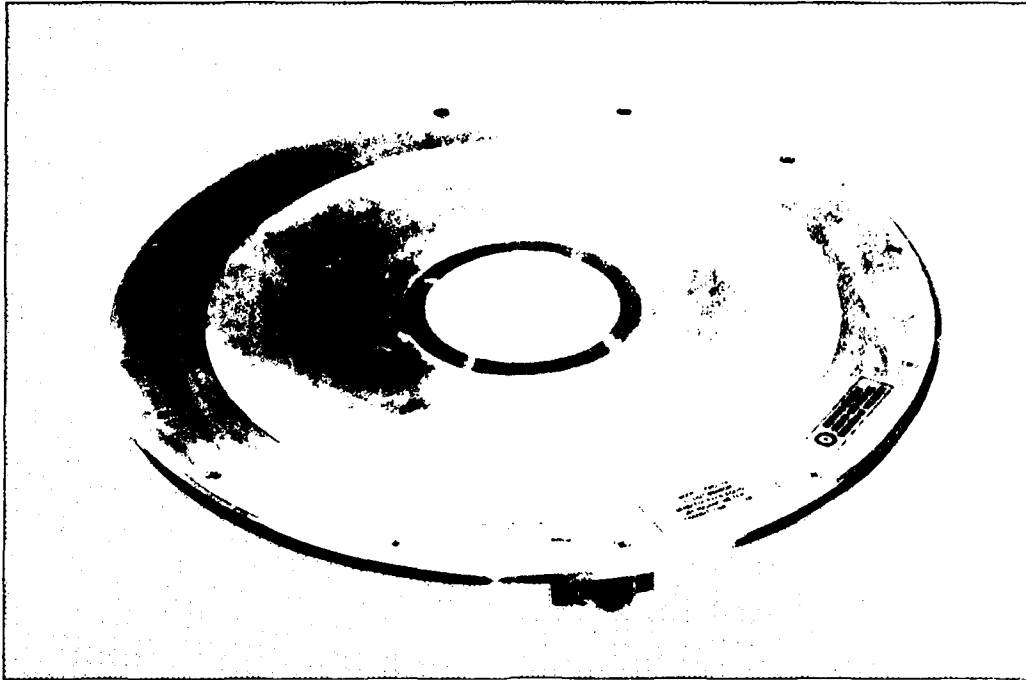
The FPD (Flush Plate Dipole) sensor is mounted in a conducting surface (ground plane, aircraft wing, etc.) and used to measure the normal component of the displacement current ( $d\vec{D}/dt$ ). It can also be used to measure the time rate-of-change of surface charge density  $dq_s/dt$ . (Data Sheet 1117 describes special  $q_s$  sensors.) The FPD sensor is extremely useful in EMP or lightning fields of high electric stress or where minimum perturbation is required. A special version adapts to the wing tip of a C-130 aircraft used for in-flight lightning measurements. The sensor is a passive device and requires no power.

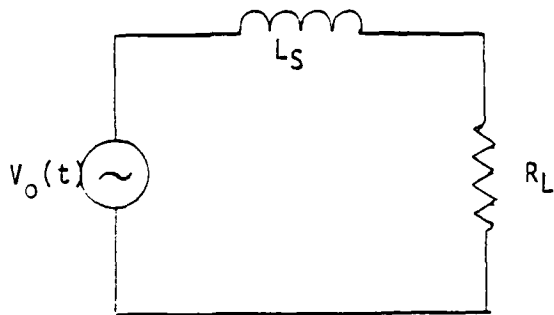
## Equivalent Circuit (Reference 5)

$L_s$  = Slot Inductance $R_L$  = Load Resistance

$$V_o(t) = \dot{B} A_{eq}$$

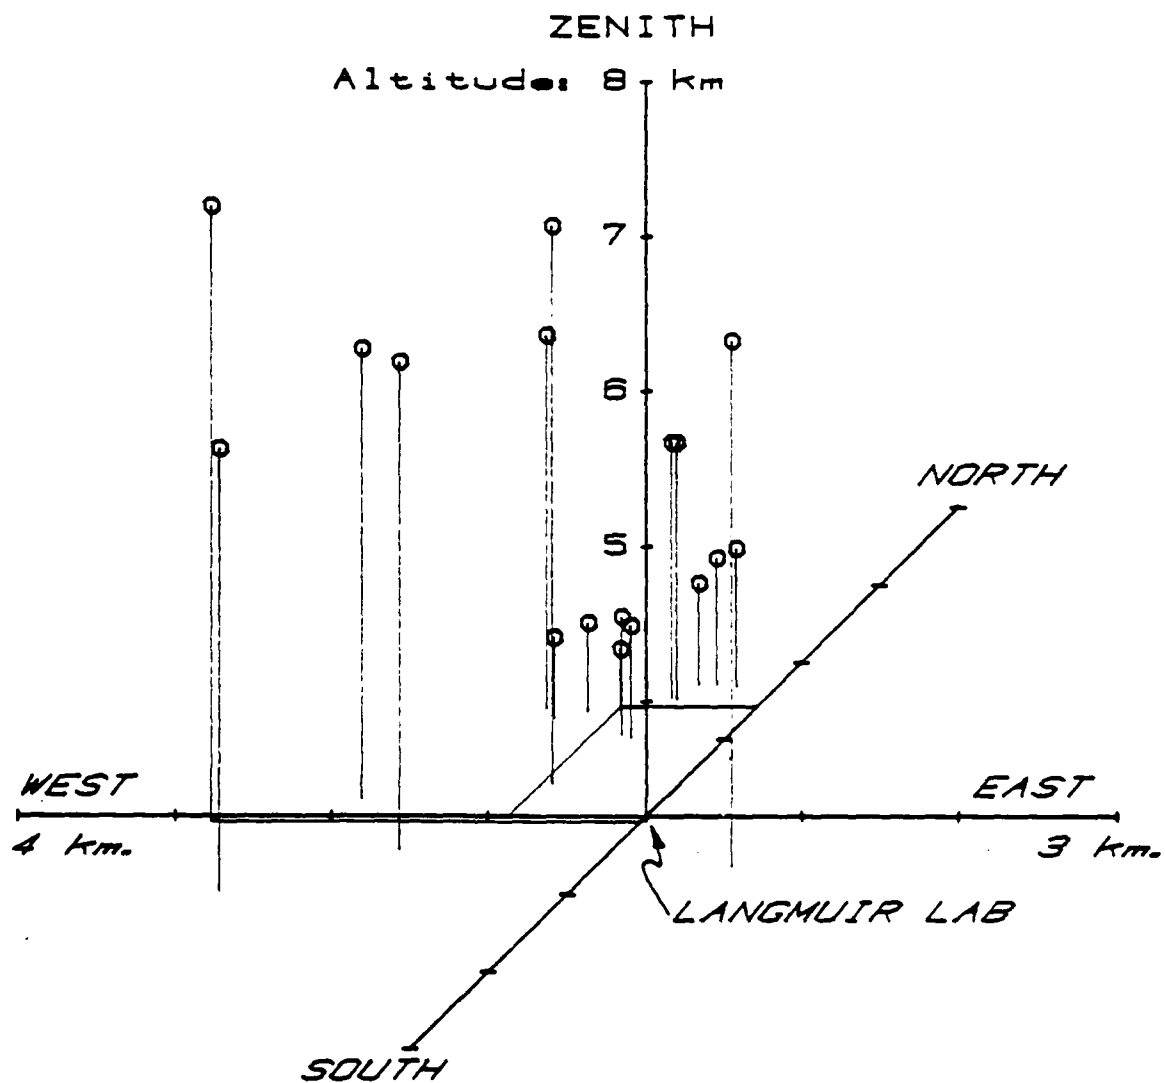
Figure E-5a. Acoustic Reconstructions of the Thunder Source Locations for the Second Triggering Lightning on Day 81211 (July 30, 1981).

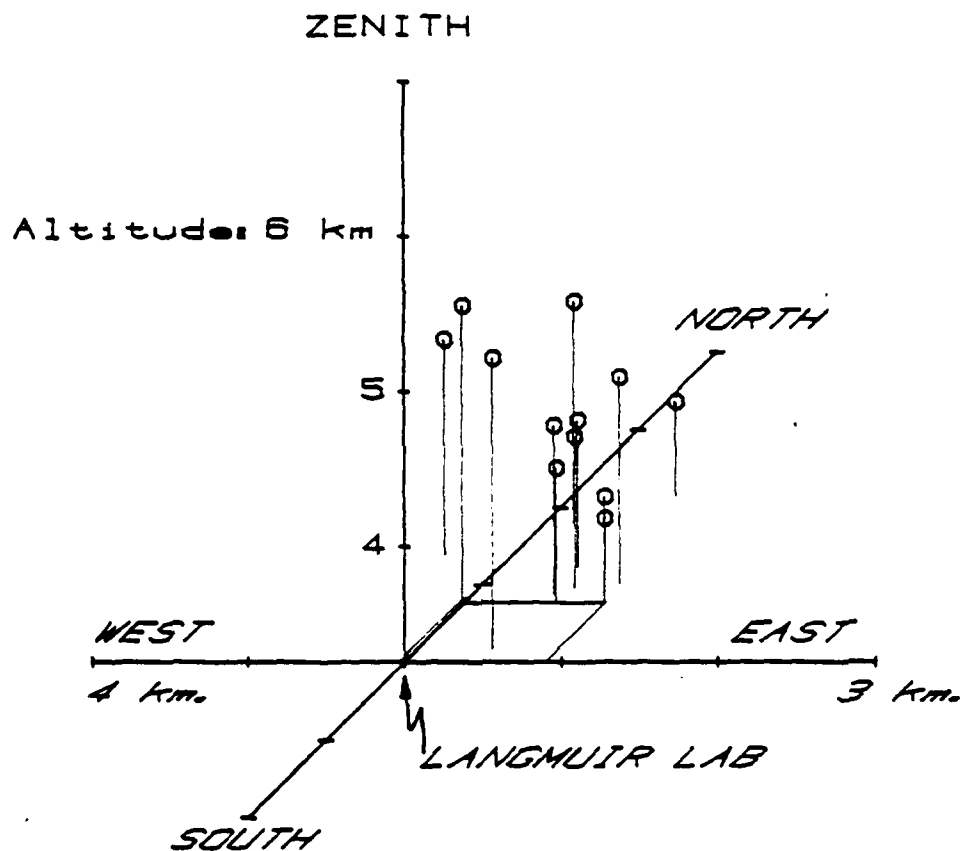
Figure E-5b. Acoustic Reconstructions of the Thunder Source Locations for the Second Intra-Cloud Lightning that Lowered Positive Charge from the Region of the "Lower-Positive-Charge-Center" Created by the Rocket-Triggered Lightning at 13:03:08 MST.

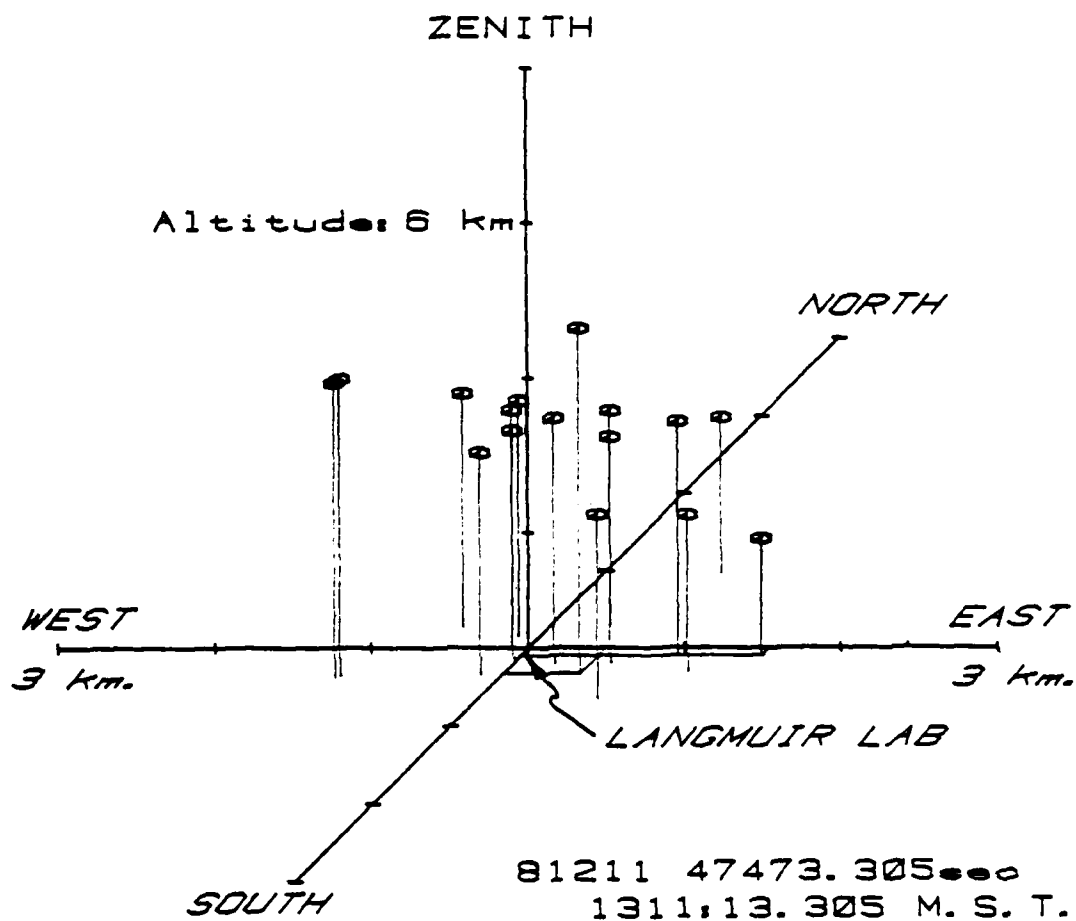
Figure E-5c. Acoustic Reconstructions of the Thunder Source Locations for the Intra-Cloud Lightning that Lowered Positive Charge from Below the Free Balloon. This flash was caused by the 'lower-positive-charge-center' created earlier by the rocket-triggered lightning.

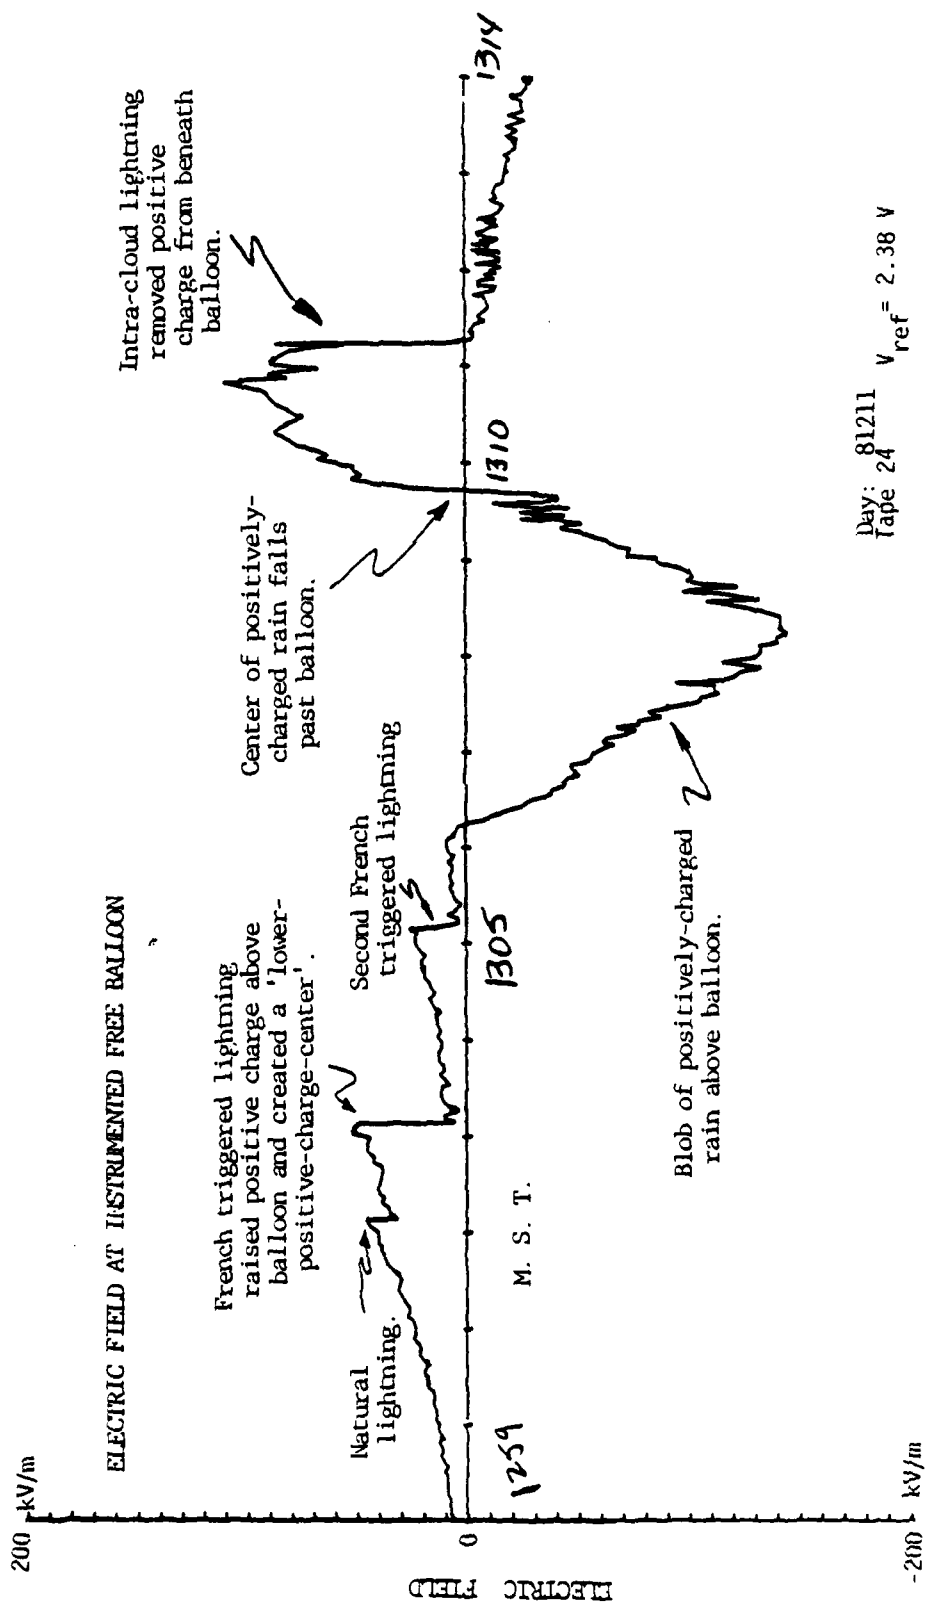
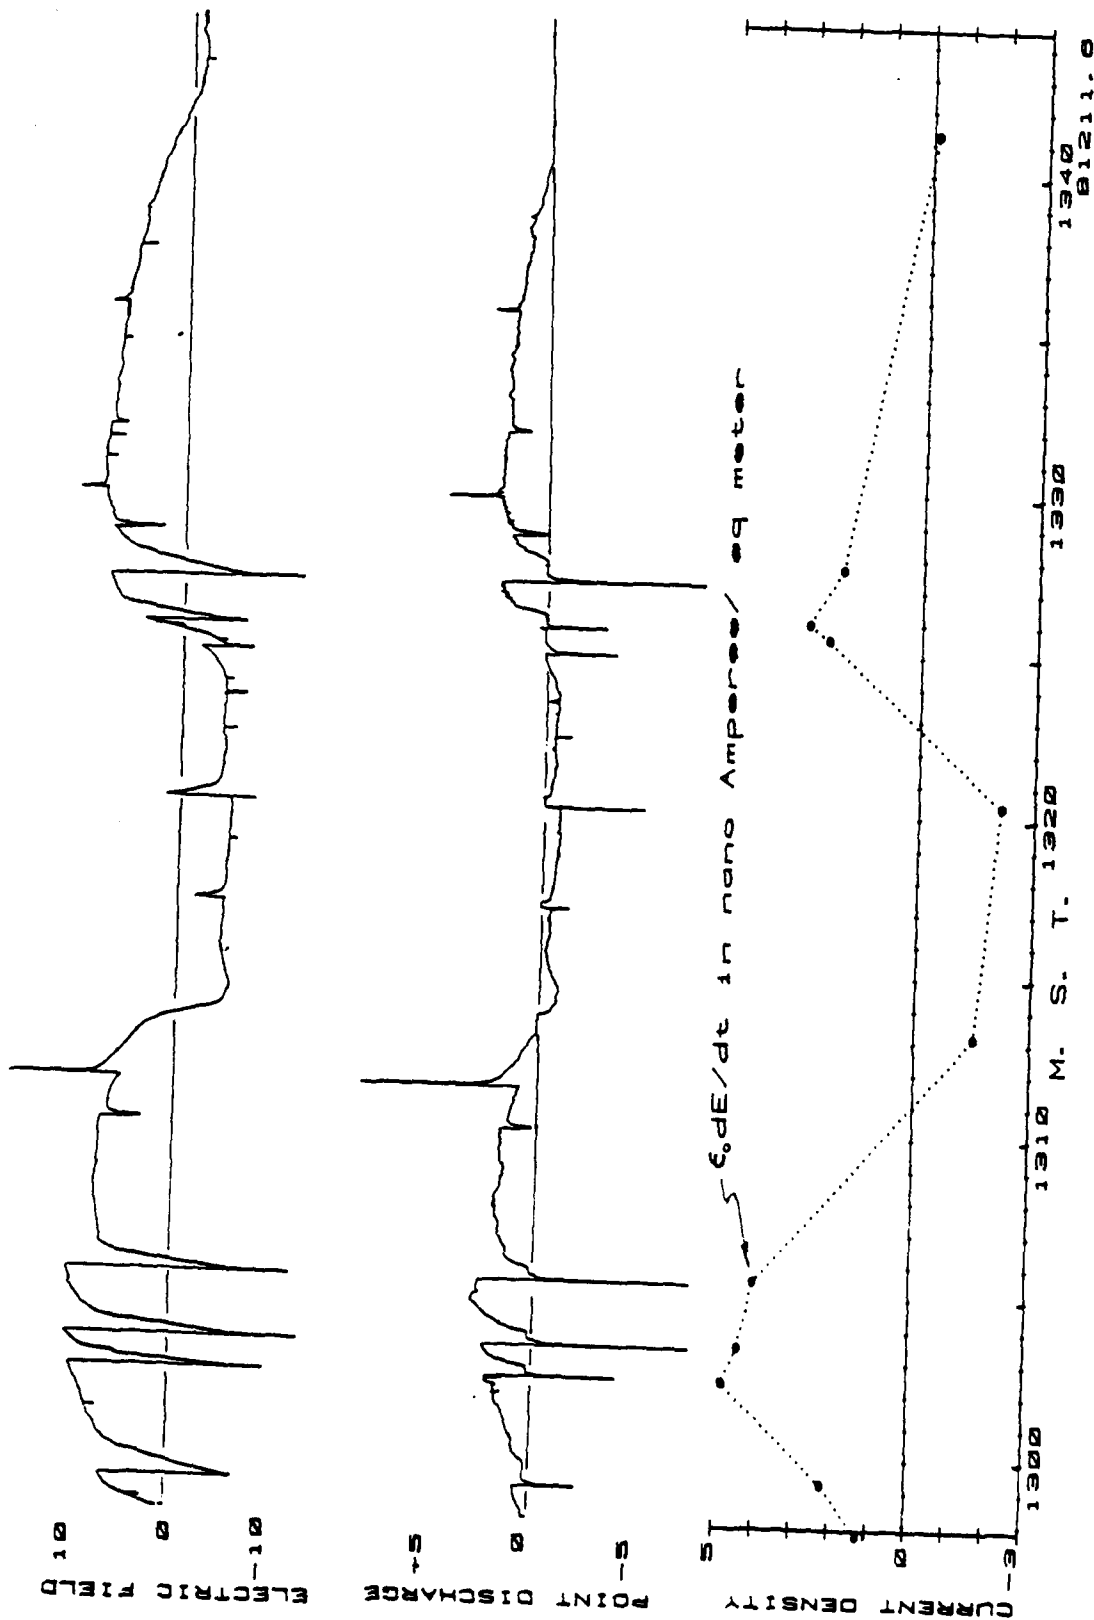
Electric Field, Point Discharge Current and Displacement Current Density at the Kiva on South Baldy Peak During the Thunderstorm on Day 81211 (July 30). The French triggered lightning at 13:03:08 and 13:05:10 MST and caused a lower-charge-center in the cloud. Positively-charged rain fell out and caused the bay in the electric field record between 13:13 and 13:26 MST. This excursion was seen earlier by W.P. Winn's instrumented free balloon launched at about 12:57 MST.

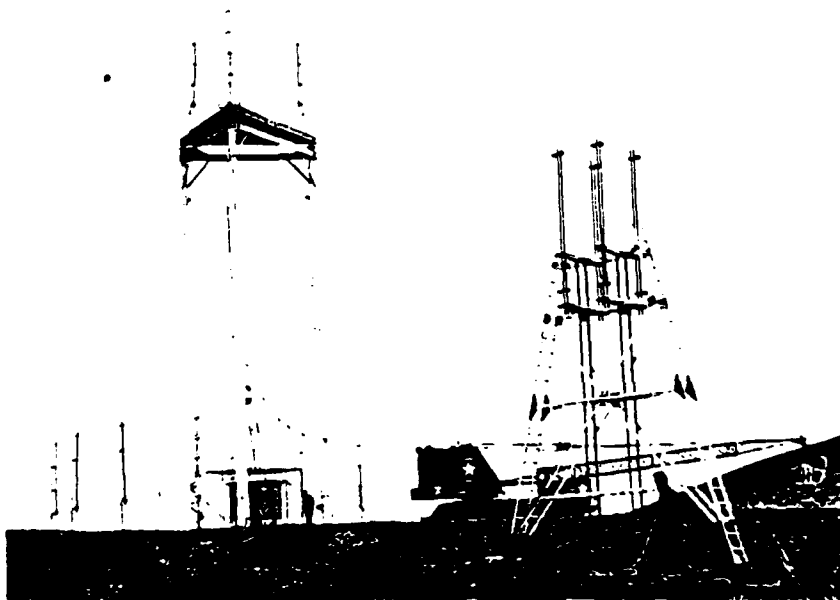
Figure E-1. A View of the French Rocket Launchers and the Instrumentation Tripod Used to Study the Effects of Triggered Lightning at Langmuir Lab During 1981. The tripod is 18 m high and supports 3 launchers and the USAF simulated aircraft fuselage.

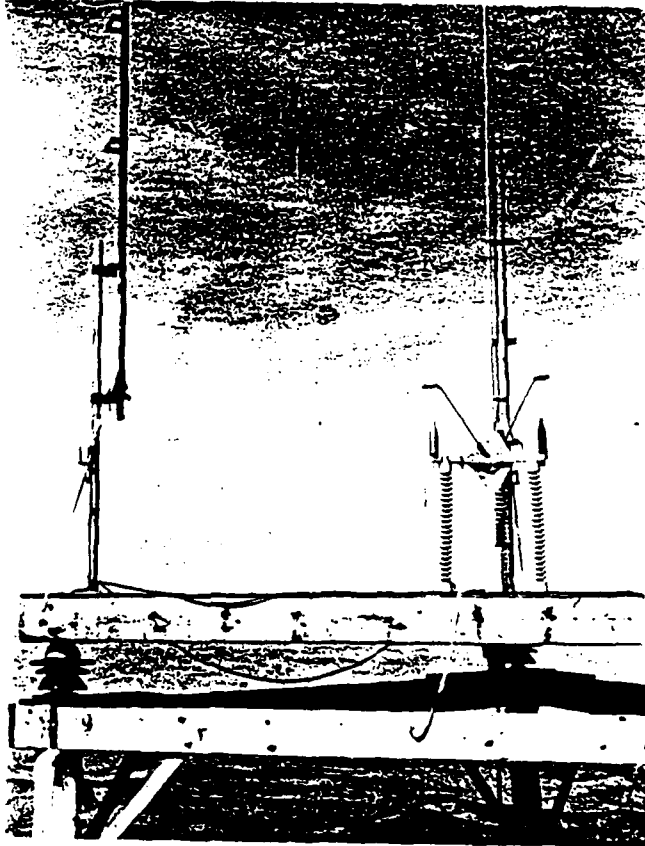
Figure E-4. A View of the Top of the Instrumentation Tripod Showing the Insulators Supporting the Platform, the Rocket Launchers, and the Wire Bobbins that Feed the Wire Trailed by a Rocket.
